# **Kelsey Creek Watershed Assessment**

A Document of the Big Valley Watershed Council

February 2010

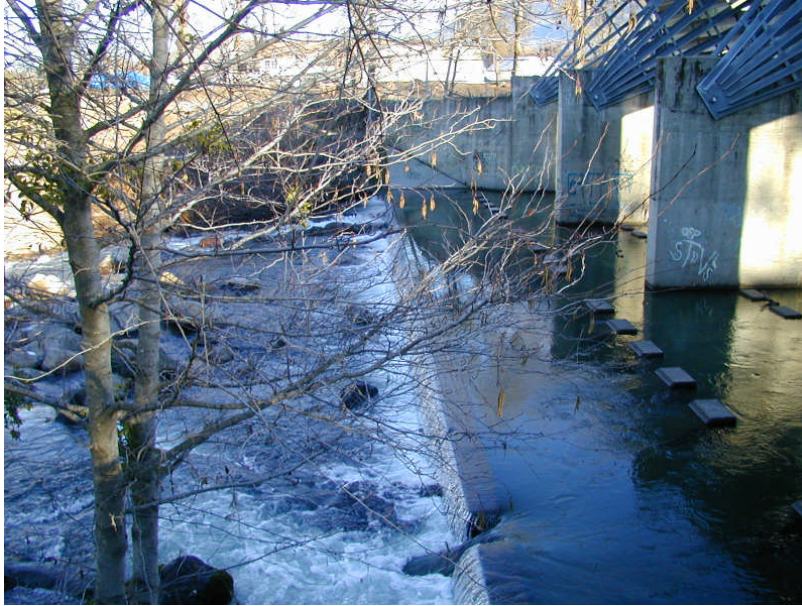
**Figure 6.1 Kelsey Creek Detention Structure with the gates up. Fish ladders on either side of the structure culminate in a narrow notch (foreground of picture) which provides limited, but not complete, passage for Clear Lake hitch.**  
*Photo by Greg Dills.*

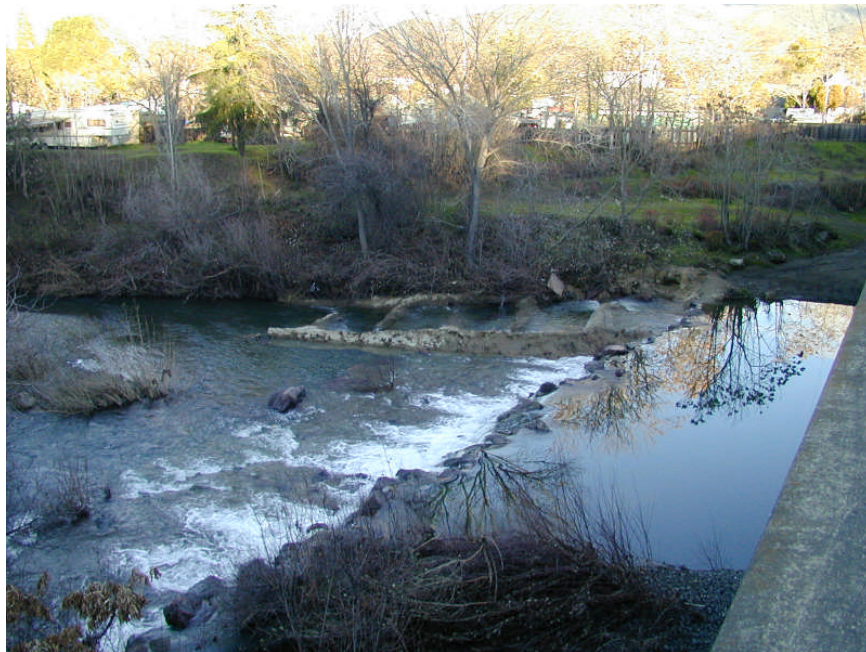
**Figure 6.2 Footing below Main St. Bridge in Kelseyville. Fish ladder, seen on far side of picture, is not used by Clear Lake hitch.** *Photo by Greg Dills.*

4. Below the Main Street Bridge, the Merritt Road low water crossing created a barrier to fish passage; however, it was replaced with a bridge allowing fish passage in 2007.

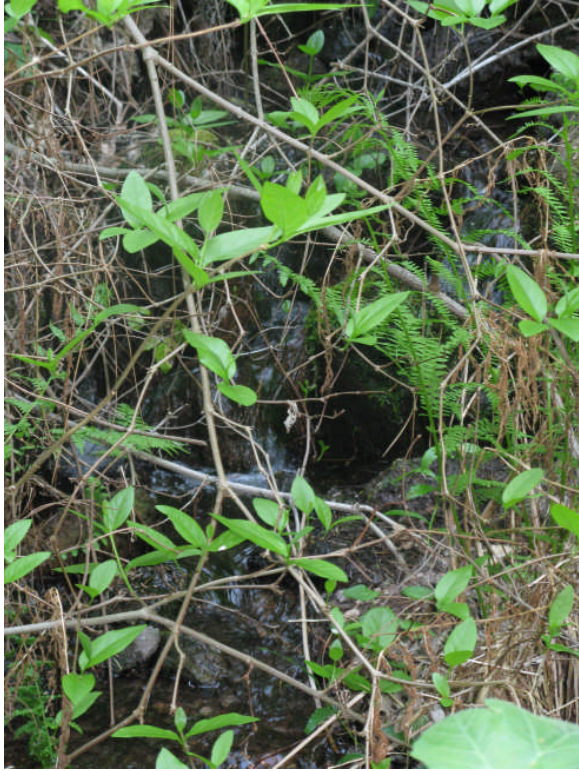
**Figure 7.2 Headwaters stream from a spring near Cobb.** *Photo by Kevin and Jennifer Ingram.*

In Zone 1, stream size is typically small, and streams flow through v-shaped valleys with no floodplains. Therefore the upland plant community is found adjacent to the stream. Where forests occur they may form a canopy over the stream. Stream water temperatures tend to be relatively cold and stable due to groundwater recharge. Zone 2 has a wider channel and more complex floodplain than Zone 1. Plant communities adapted to periodic flooding are present in the floodplain. As the channel widens, the stream is exposed to more sunlight which causes larger daily water temperature fluctuations, and an increase in the average water temperature. In Zone 3 large floodplain wetlands may be present because of the flatter terrain. In addition valley hardwoods create productive and diverse riparian communities in the deep alluvial soils.

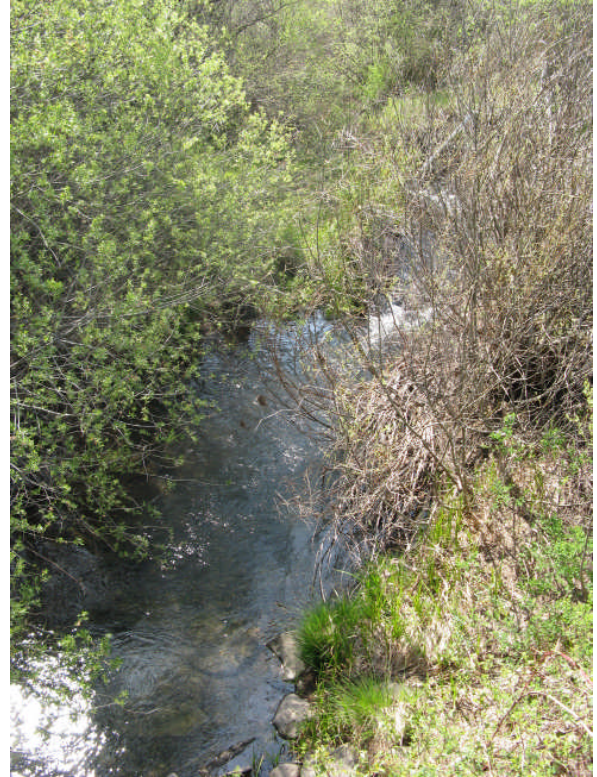
**Figure 7.3 Kelsey Creek flowing through a meadow in the upper watershed (along Glenbrook Dr. behind Jellystone Park, May 3, 2008.** *Photo by Kevin and Jennifer Ingram.*

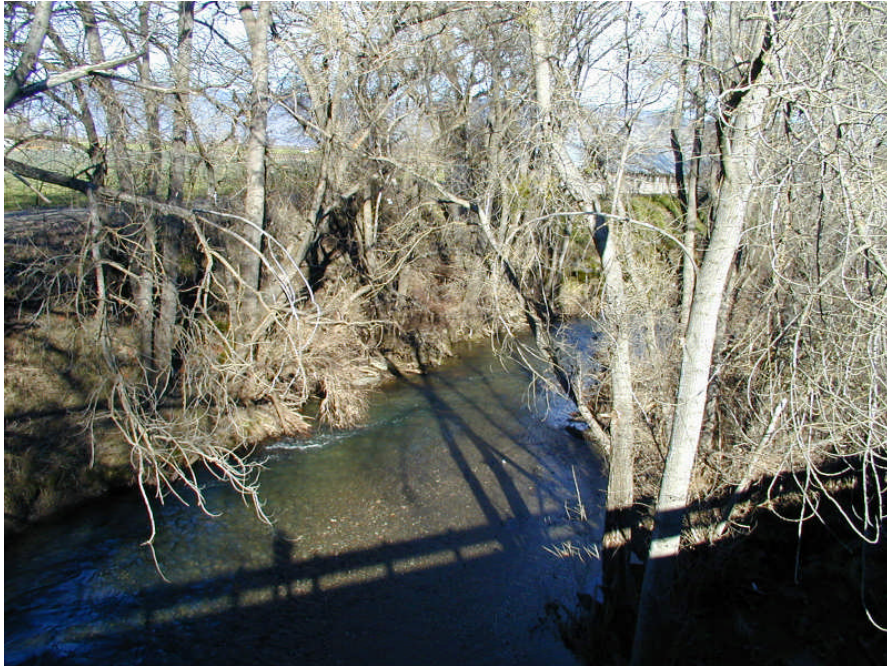
**Figure 7.5 Below the bridge at Soda Bay Rd. the bed of Kelsey Creek has dropped significantly.** *Photo by Greg Dills.*

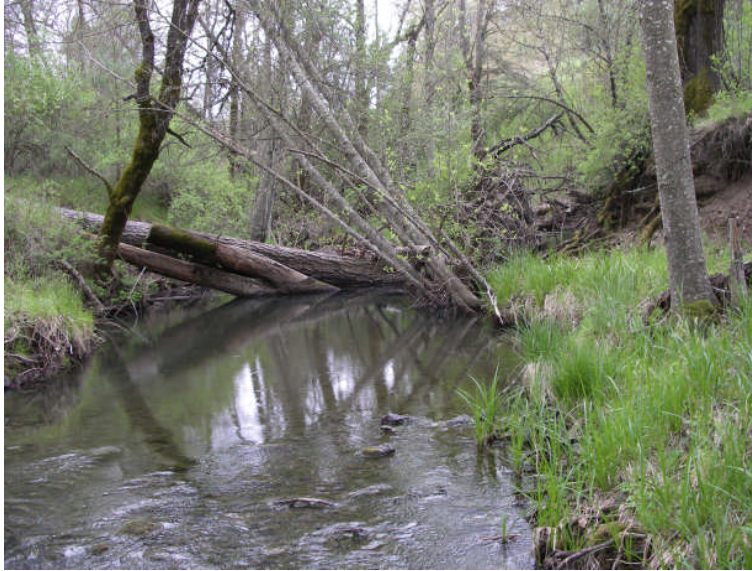
**Figure 7.7** Fallen trees create potential debris jam in Upper Kelsey Creek. *Photo by Robert Stark.*

The Big Valley Watershed Council toured sections of Upper Kelsey Creek on May 3, 2008 to view stream conditions. The group observed debris jams and streambank erosion ([Figures 7.7](#) and [7.8](#)). The group concluded that there was a need for hydrologic studies to determine whether these conditions were caused by current land use activities, and there was a need to continue monitoring stream conditions (Kevin Ingram, personal communication).

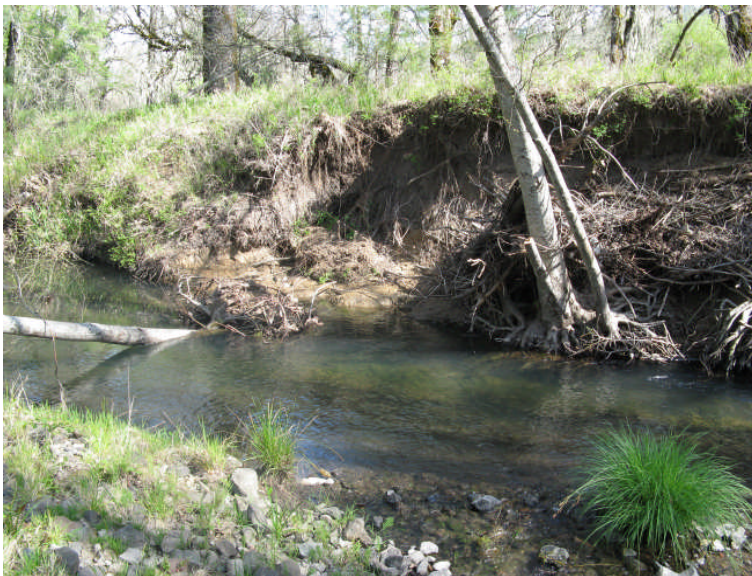
**Figure 7.8** Streambank erosion in Upper Kelsey Creek, May 3, 2008. *Photo by Jennifer and Kevin Ingram.*

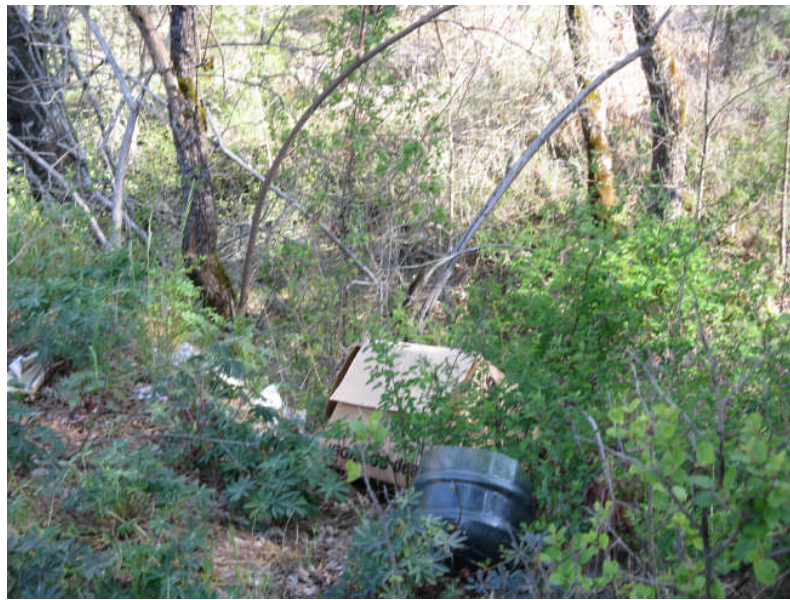
**Figure 16.1 Trash dumped in the Kelsey Creek floodplain, May 3, 2008.** *Photo by Jennifer and Kevin Ingram.*
